**AN ARCHAEOLOGICAL DESK BASED ASSESSMENT FOR THE
PARISH CHURCH OF ST.LAURENCE, TELSCOMBE, EAST SUSSEX.**

Archaeology Services Lewes

Project number: ASL 141-17

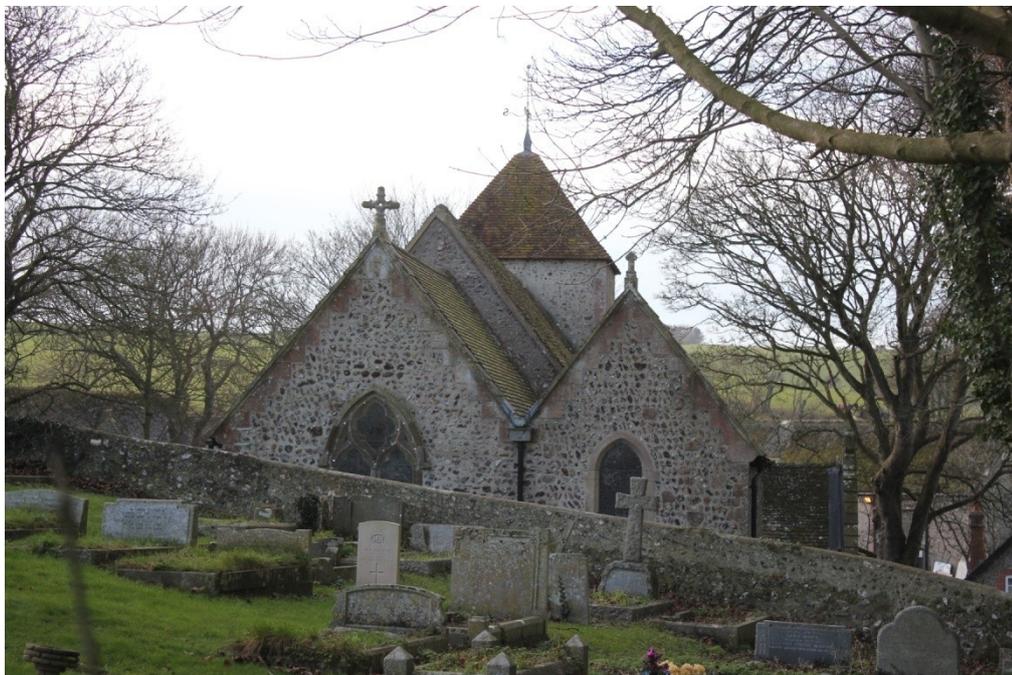
Plate 1. The east side of the church viewed from the west.

The ground rises to the south and east sides and there is a walled graveyard on the far east (Plate 1), with a small strip of graves on the north side bounded by a flint retaining wall and line of trees. Beyond this the ground falls sharply on the north side towards a farm track and public footpath (Plate 2) which runs east to west from Gorham's Lane to open fields beyond. A retaining flint wall has been built on the west side where the plot faces Gorham's Lane and this wall is mounted by iron railings. There is a large tree in the north-west corner.

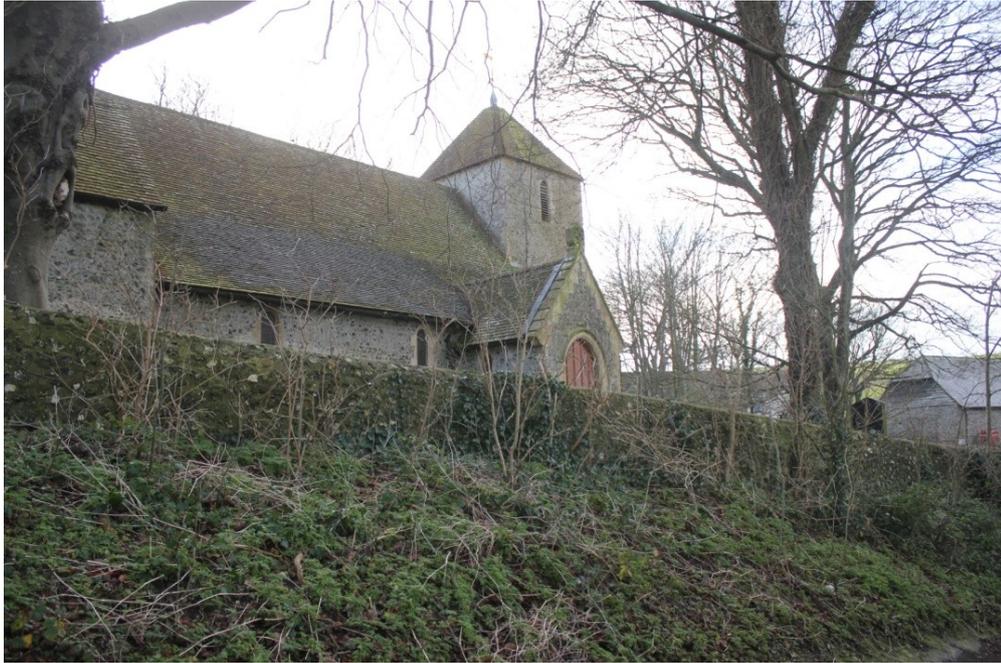
Plate 2. North side of the church viewed from a farm track.

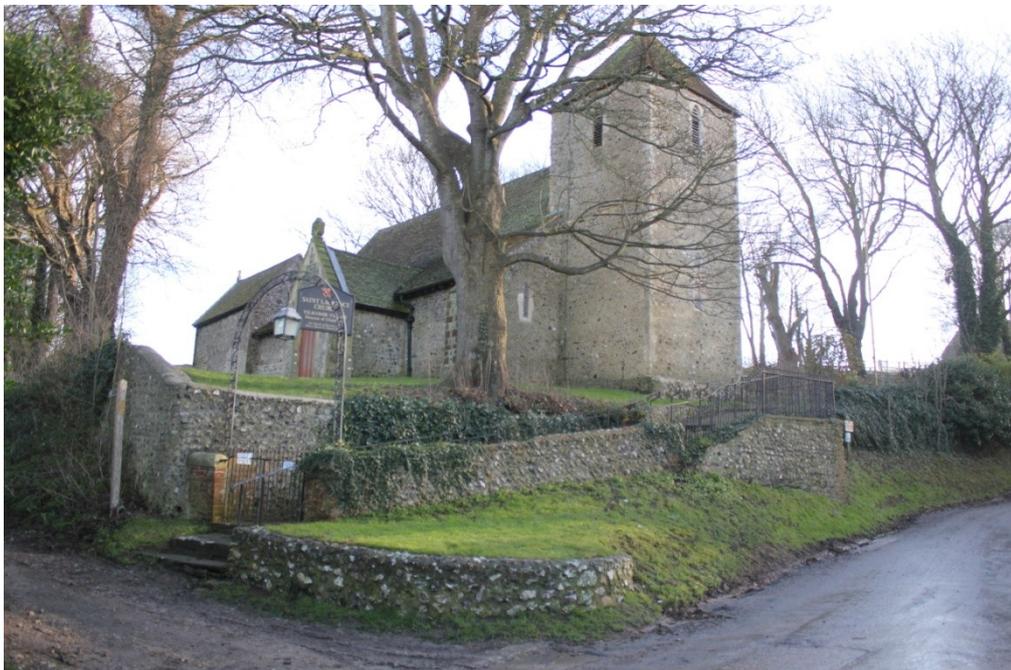
The plot is accessed through a cast iron gate at road level in the north-west corner, which has an iron filigree arch and lamp above (Plate 3; all 19th century). This gives access to a modern brick path, with eight steps up, which then follows around the west and south sides of the church to the south entrance and ultimately towards the graveyard at the rear of the plot.

Plate 3. The building viewed from the north-west corner showing the gate and lamp arch above.

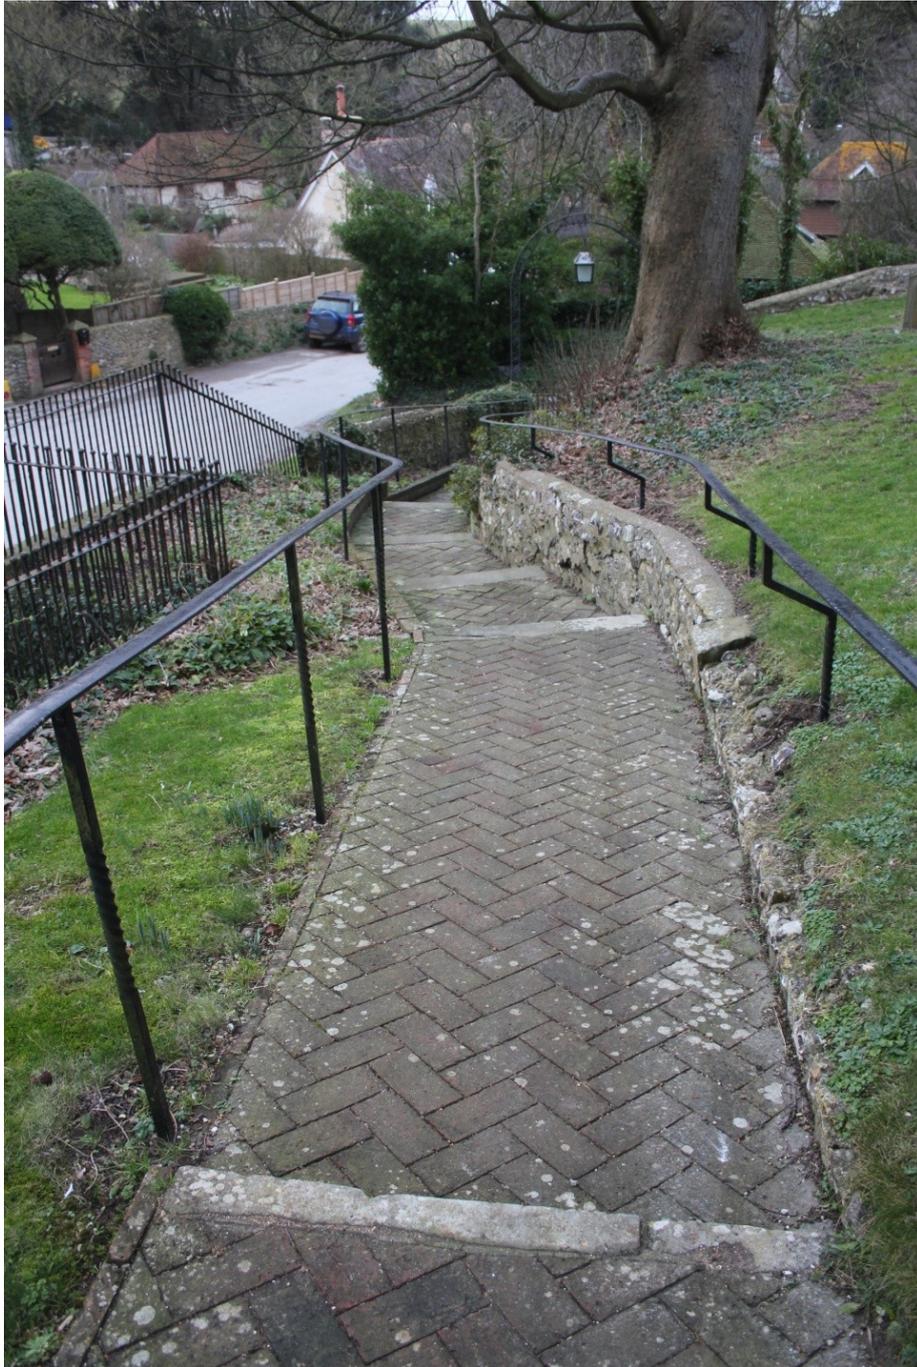
Plate 4. Modern brick path to west side.

The path is flanked by barley twist posts mounted by a hand rail (Plate 4; likely 20th century) and the path also forks southwards towards Bank Cottages where a small wooden boundary gate lies between the two plots. There are no gravestones immediately flanking the south wall (apart from one to the west of the south entrance) or within the south west corner of the plot and there are no headstones in the far north west corner of the plot but there are a small groups to the east side of the vestry and east of the chancel. Additionally there were no gravestones seen in the west side of the plot.

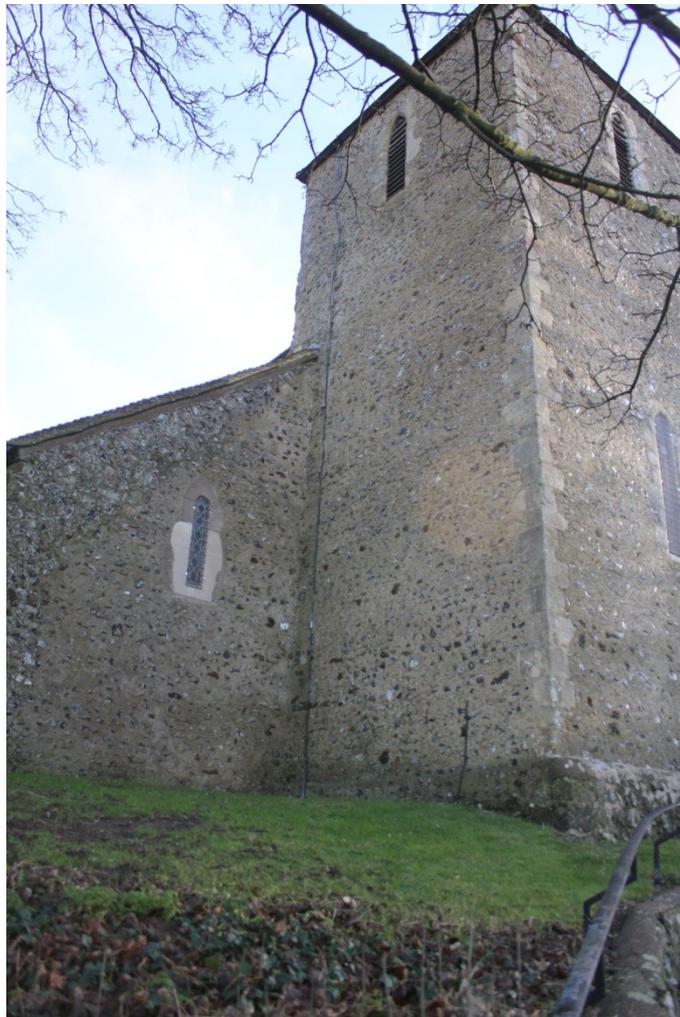
The tower (Plate 5) is believed to have been added in the late 12th century and is constructed from natural flint nodules and ironstone with some faced flint and the mortar (modern) is lime with approximately 25% small rounded water worn flint gravel. There is a slightly projecting flint and ironstone plinth on which the tower sits. The quoins are light yellow sandstone and within the south wall there is a slender, round headed sandstone window at ground floor and a two-pointed arched bell opening at the top level (Plate 6). It is believed that these windows are 19th century replacements although it would appear that some elements may be re-used, particularly the top window in the south wall. In the west wall is a larger, round-headed window at ground floor level, which is probably medieval (1355-1530⁹) and a two-pointed arched bell opening at the top level.

Plate 5. The tower viewed from the north-west showing the plinth and round-headed windows.

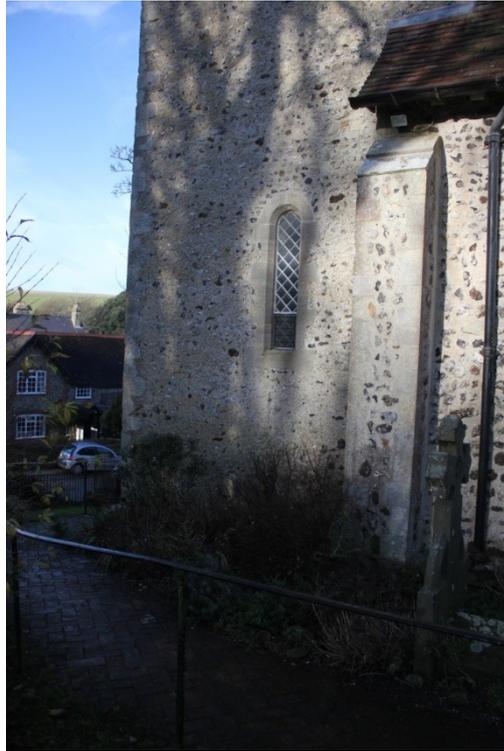
Plate 6. 19th century window in the south wall of the tower.

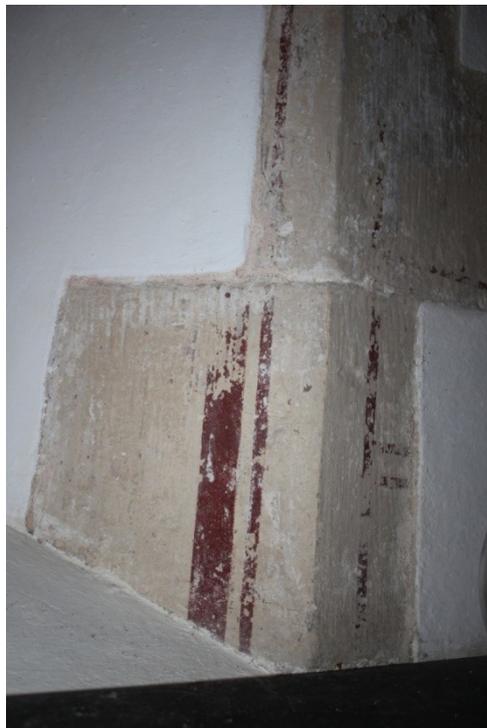
The internal quoins of the window on the west wall have some evidence of wall painting, which are fragmented and incomplete (Plate 7). The paintings consist of simple, ochre coloured lines.

Plate 7. The remains of wall paintings on the north side of the Tower's west window.

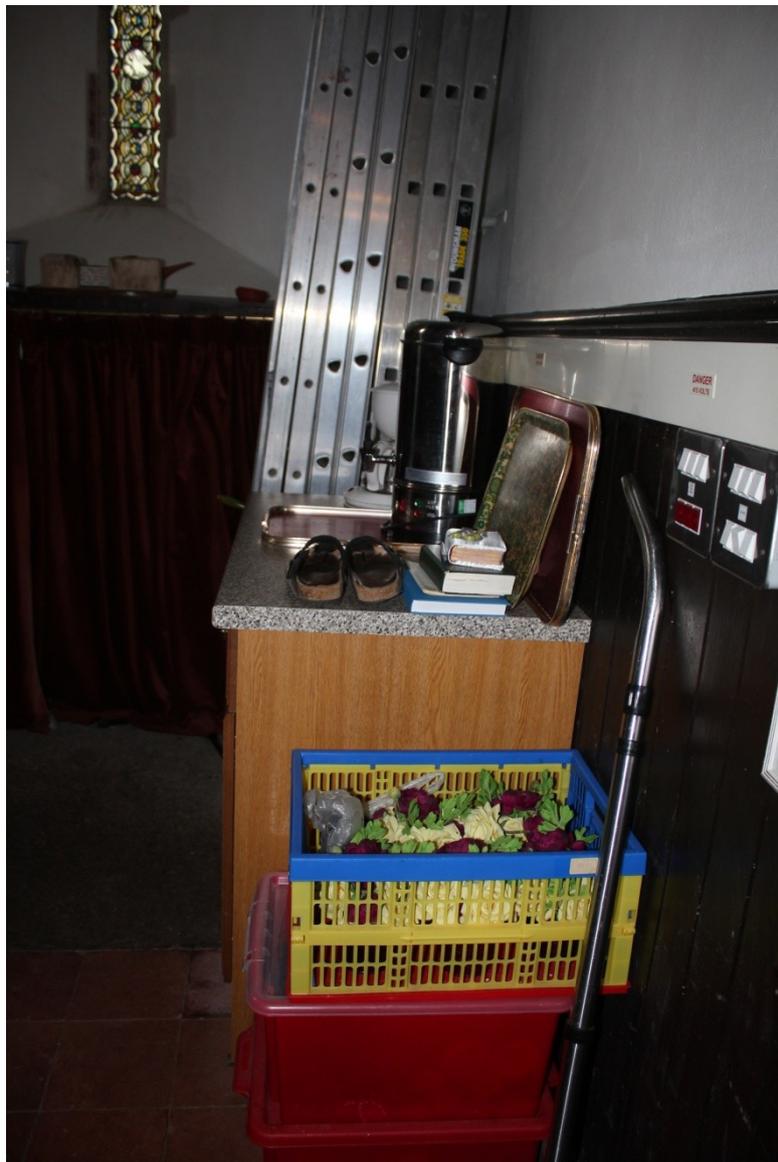
Internally, the walls have a 19th century wooden tongue and groove panelled dado with rail to the north, west and south sides at a height of 1.46m above which the walls are partly plastered and painted white. Beyond the painted surfaces are exposed flint and stone walls which meet an inserted plastered ceiling at approximate half height level. There is also a shallow skirting board and the floor is partly laid with quarry tiles on the east side ((1.90m E-W) and concrete on the west side (1.46m E-W). There is a live electric cable running E-W on the north wall horizontally across the top of an existing kitchen cupboard with work top (Plate 8). There is a modern electricity fuse and junction box in the south corner.

Plate 8. 19th century dado panels and modern sink unit on the north wall of the Tower.

- 10.3 However, it is recommended that further building recording is carried out, in the form of additional recording of the tower wall, *if* the 19th century panelling is to be removed. In addition, it would be recommended that the floor in the vestry be recorded once the carpet has been lifted. A brief photographic record would suffice in both cases.

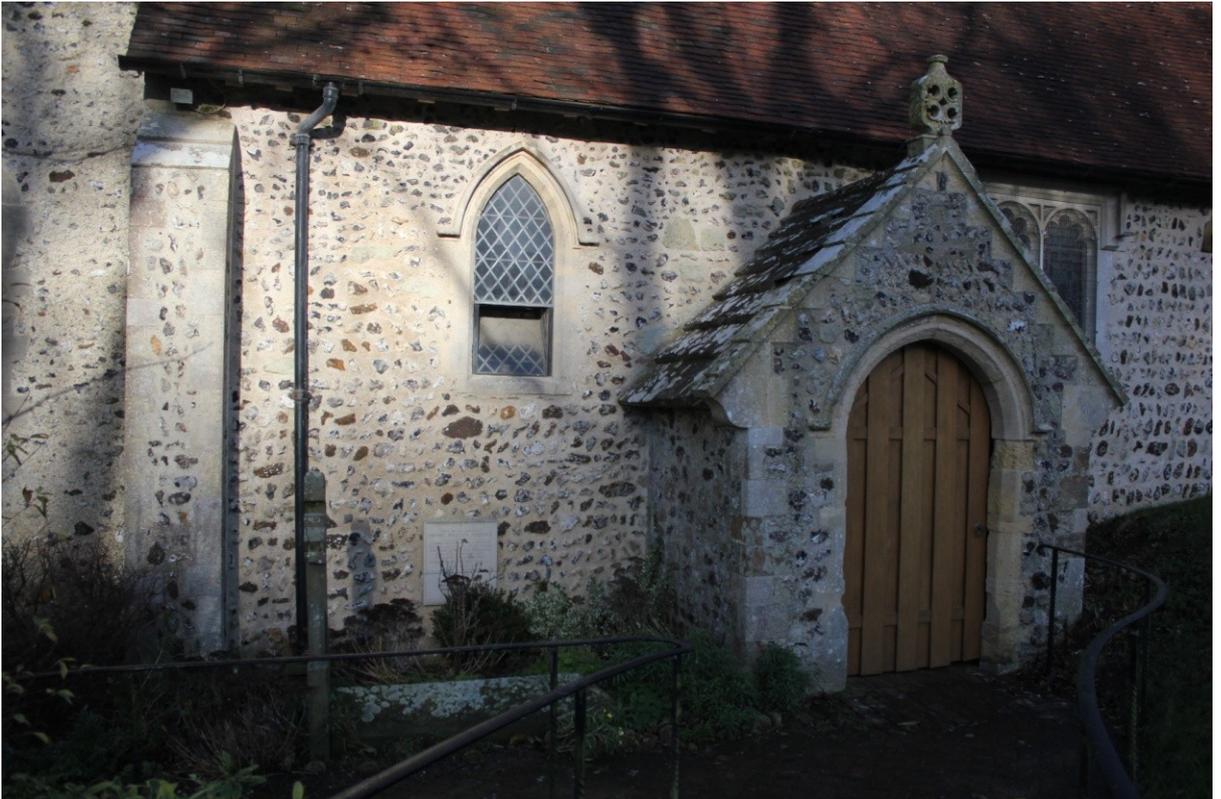
The nave is thought to be the earliest part of the church and is at least early 12th century in date (could be earlier) and has a buttress to the west corner and is constructed with sandstone; flint nodules and ironstone with occasional faced flints and some greensand blocks present with mortar as before (Plate 9). There is a two-pointed lancet window on the west side with label mould and returns above in yellow (Caen?) stone. There is a simple leaded diamond glass lights within. This too is believed to be 19th century replacement.

Plate 9. South wall of the Nave with 19th century porch addition.

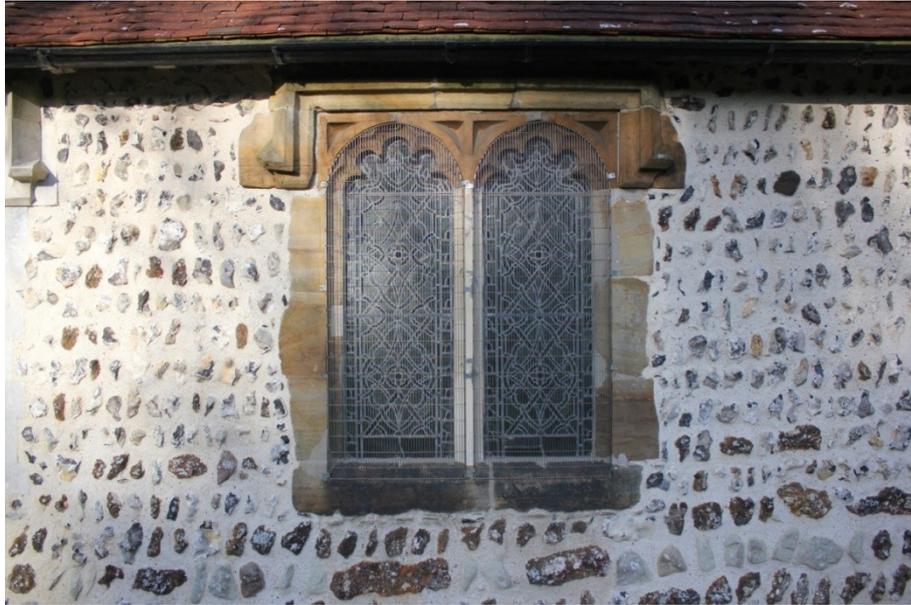
A square-headed window centrally positioned in the south wall of the nave is 19th century and a third window on the east side of the nave, also square-headed, is believed to be 15th century (Plate 10). Both have label-moulds with returns and have two round-headed lights with stained glass panels and a central mullion. The flooring is a mixture of 19th century and medieval ceramic tiles along with wood block.

Plate 10. 15th century square-headed window in the south Nave wall.

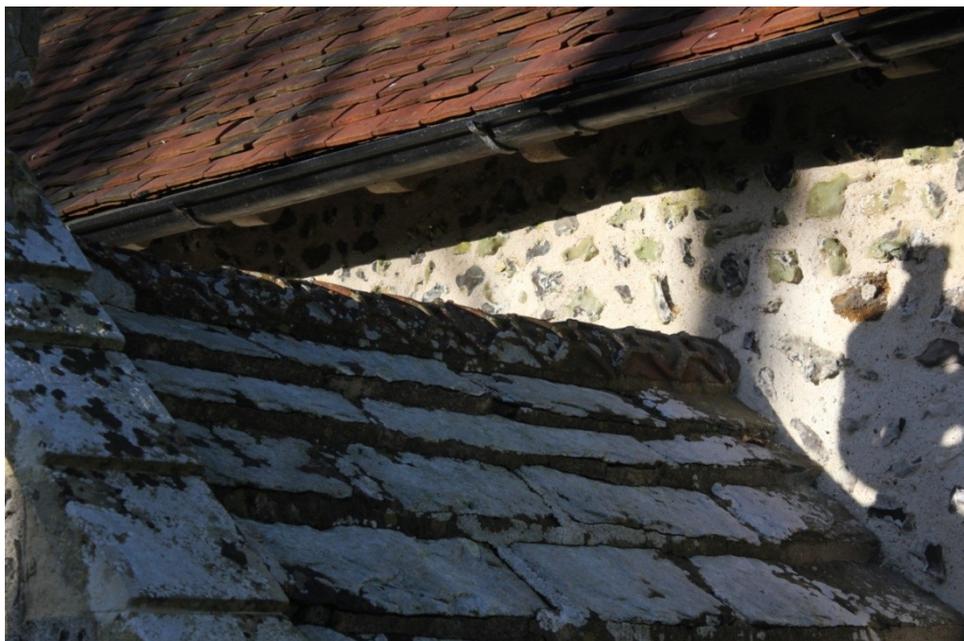
The south porch is 19th century and is constructed with flint nodules; greensand; yellow sandstone and ironstone with the same mortar as used elsewhere. It has a round arched sandstone doorway with label mould and returns above (in fine-grained yellow stone) with projecting eaves corbels with a stepped stone gable and ornate pendant to the apex. The roof is covered with Horsham slab and there is a moulded decorated ceramic ridge (Plate 11). There is a small round-headed yellow sandstone window on the east side.

Plate 11. Re-used Horsham slab tiles on the south porch.

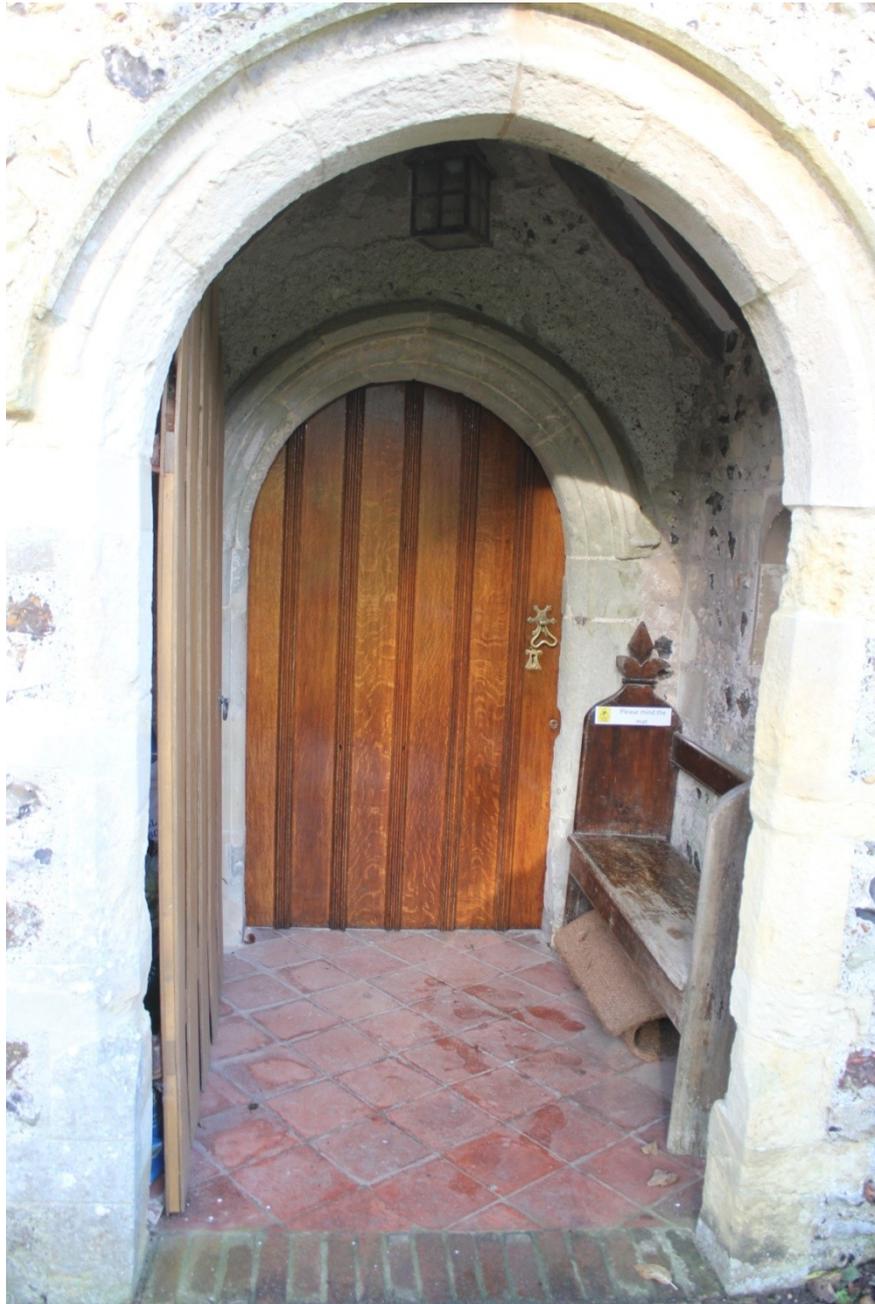
Plate 12. South Porch with re-modelled 12th century doorway and 19th century door.

The round headed south doorway is adapted from the original 12th century stonework with probable 14th century mouldings, although the oak door with brass fittings is much later and also 19th century (Plate 12). The rafters (with ridge-board above) above can clearly be seen to display former use and have come from elsewhere. The floor is laid with quarry tiles.

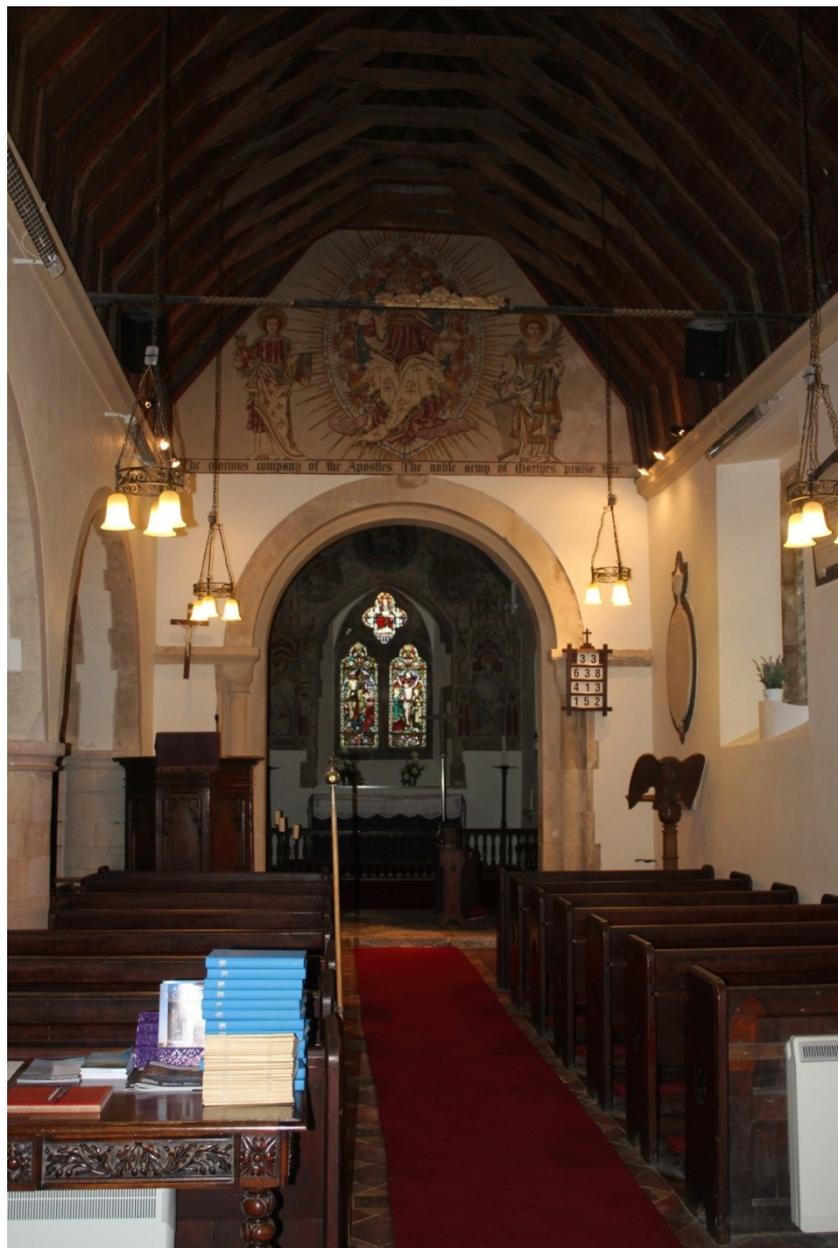
Plate 13. Looking through the Nave to the Chancel; note early 20th century murals.

The east wall has a large 14th century two-light window (Plates 13 and 14) with label mould and quatrefoil head which also has traces of much earlier wall painting on the interior which does not match a later 20th century chancel arch and altar mural in colour, texture or saturation (Plates 15-17). These later murals were painted in 1905 by Messrs.Castle and Anderson, donated by Ambrose Gorham¹⁰.

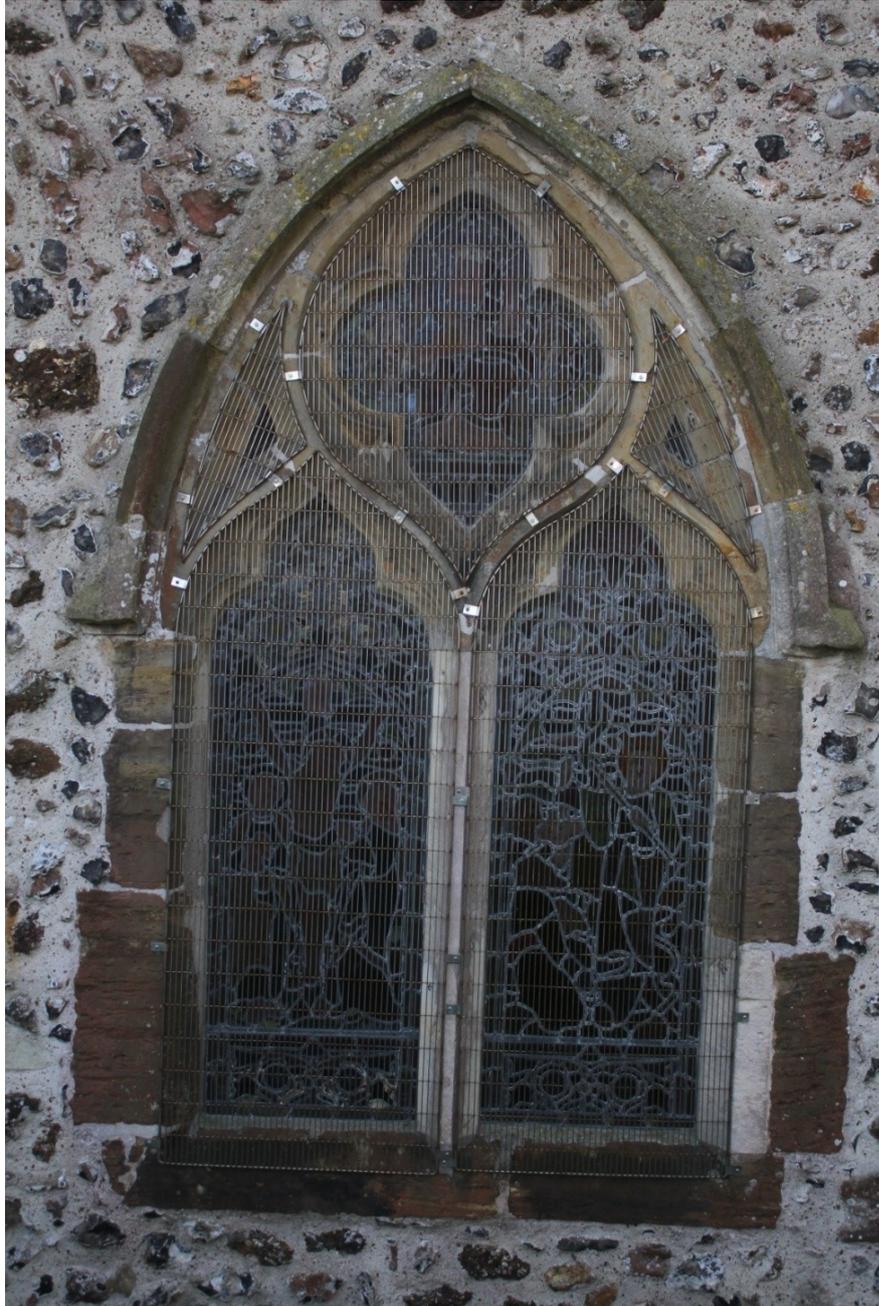
Plate 14. Two-light window with quatrefoil in the east wall of the Chancel.

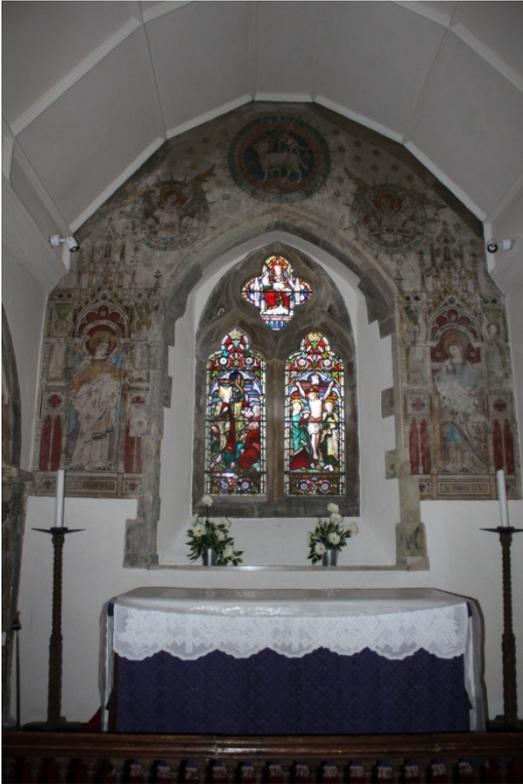
Plate 15. 20th century mural on the east wall.

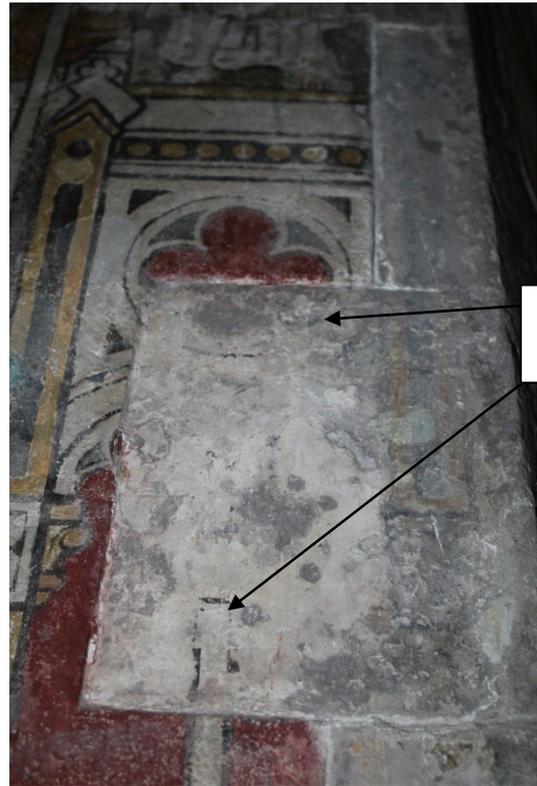
Plate 16. Traces of earlier painting on the quoin of the altar window.

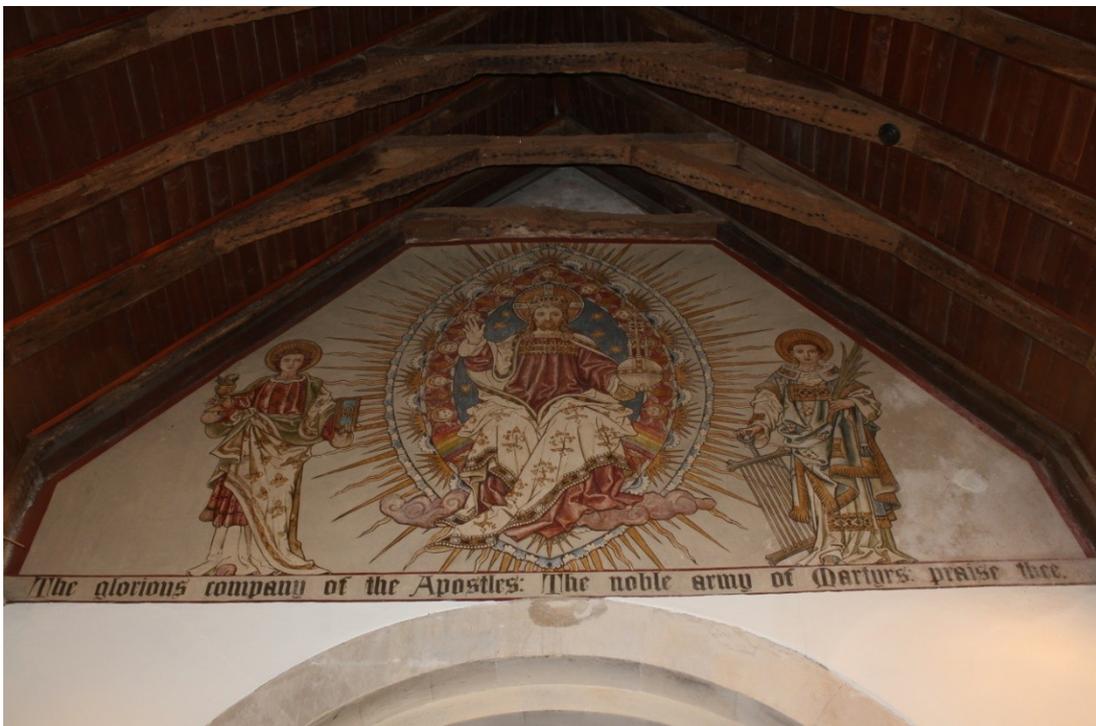
Plate 17. Early 20th century murals above the Chancel arch.

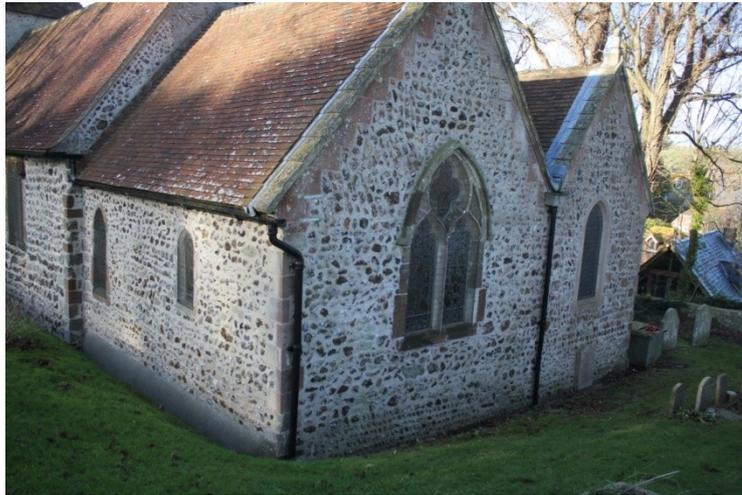
The north Lady Chapel is thought to have had 12th century origins and has been added to or replaced at a later date, probably also during the 19th century renovations. A lot of re-building of the church took place during this period so it is not possible to state which is original medieval fabric with regards to the entire north side of the building. The east wall is similar in construction to that of the chancel but the roof line is lower (Plate 18). There is a central lead hopper in the valley between the two roofs which is also 19th century and the lancet window is believed to contain glass fragments from Selby abbey, Yorkshire, placed here in 1937.

Plate 18. The Lady Chapel to the right of the Chancel.

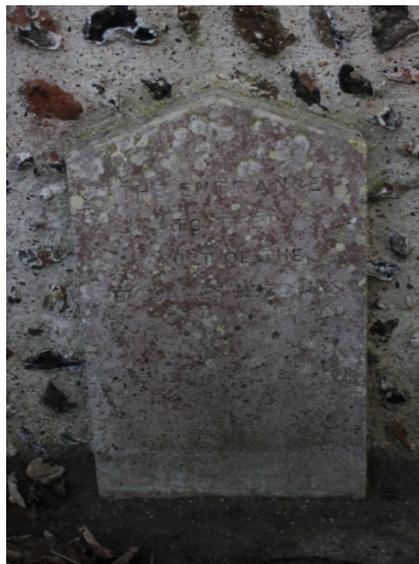
The lancet window here does not have a label mould and is plainer. A headstone erected against the wall here is inscribed: *'The entrance to the vault of the Rev. James Hutchins'*.

Plate 19. The vault entrance on the east wall of the Lady Chapel.

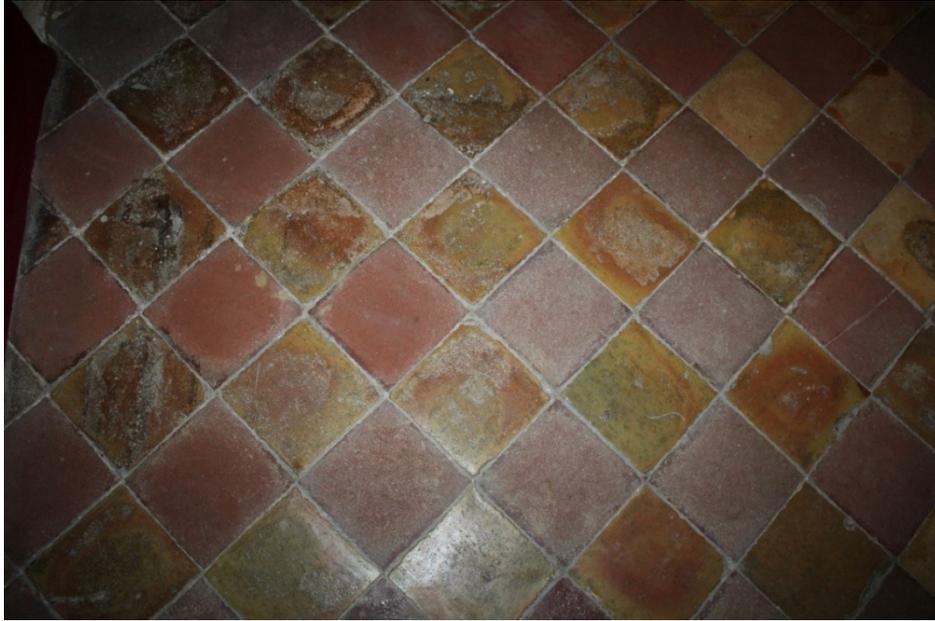
This is located underneath the window on the east side. The north east corner of the chapel has stone quoins and there are graves on the east bank as well as on the north side of the chapel. This side is also constructed from the same materials and the bottom 300mm of this wall is rendered. There are no windows on this north wall. The flooring is mainly laid with re-used glazed medieval ceramic tiles (Plate 20).

Plate 20. Re-used medieval glazed tiles in the floor of the Lady Chapel and Chancel.

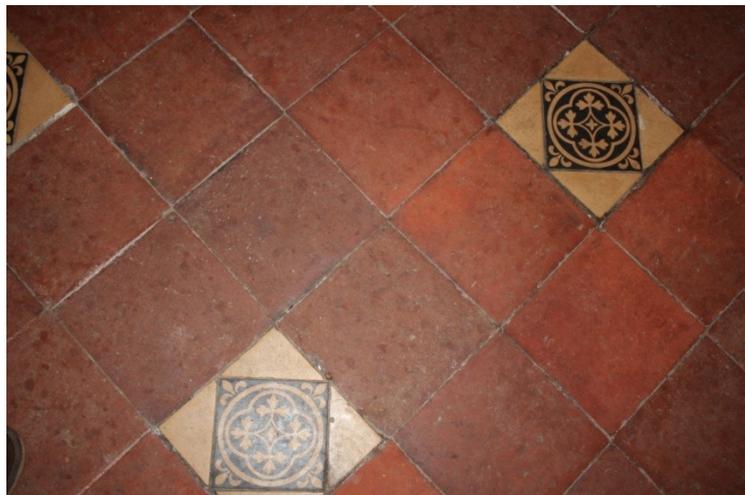
It is thought that this 19th century construction replaces an earlier aisle and is a 'lean-to' with a cat-slide roof, also in ceramic tiles and with 19th ceramic floor tiles (Plate 21) along with wood block. The evidence for a higher and wider aisle is clearly visible within the west wall (Plate 22).

Plate 21. 19th century floor tiles in the north aisle.

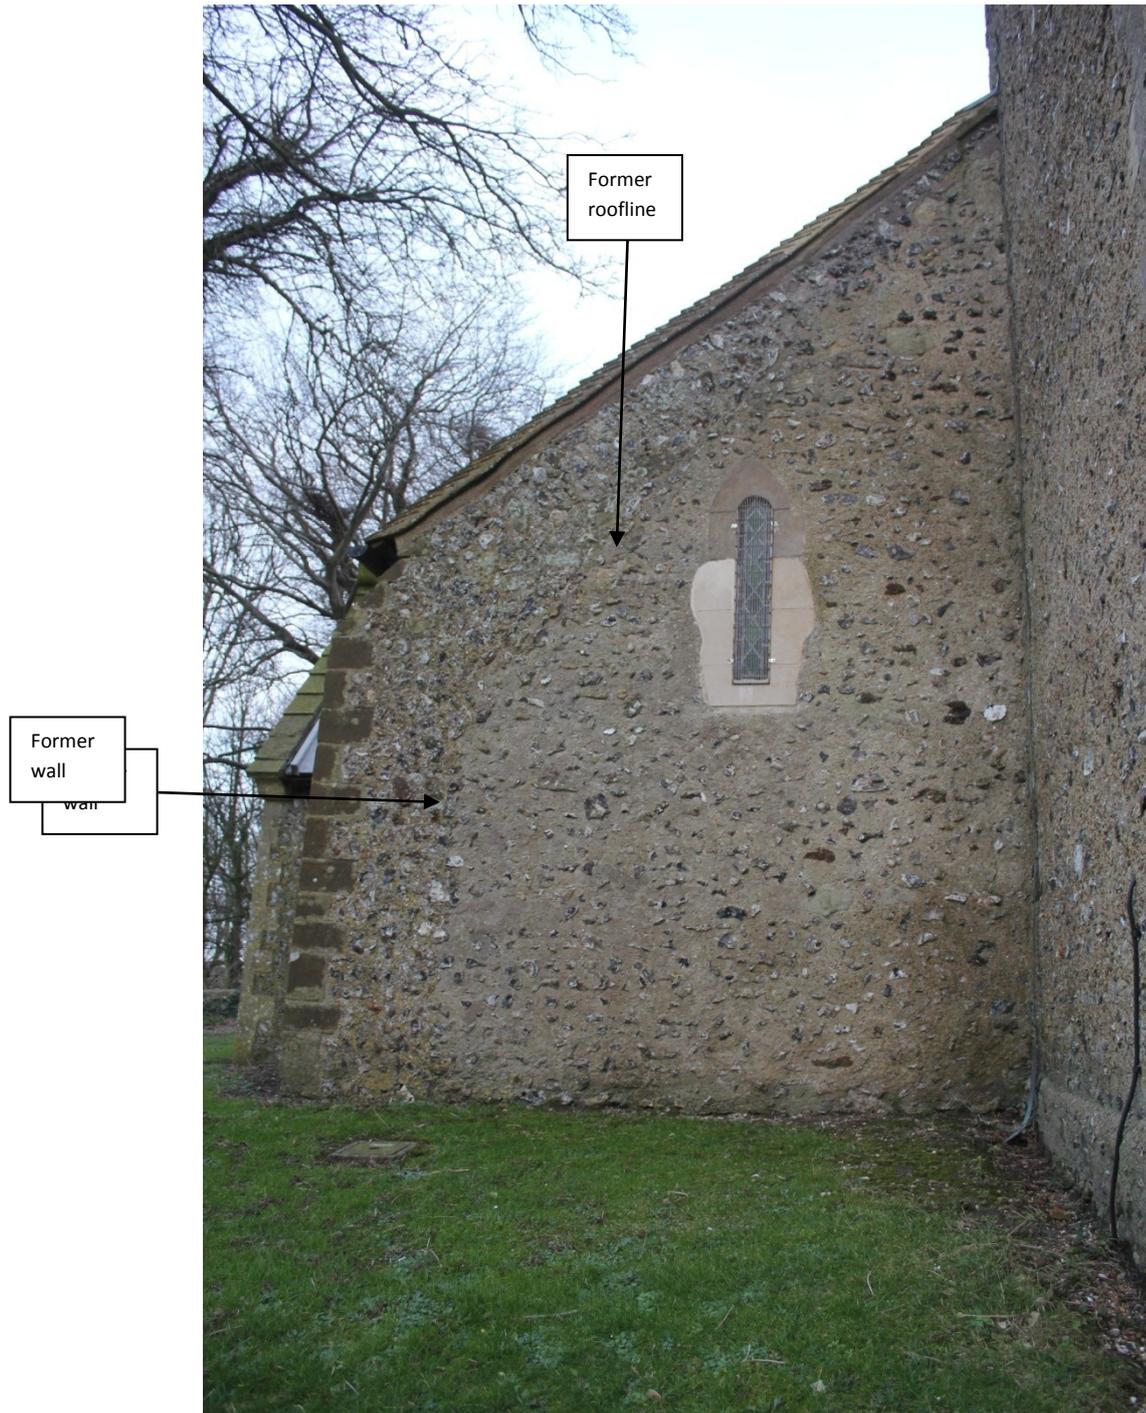
Plate 22. The scars of the former north aisle seen in the west wall.

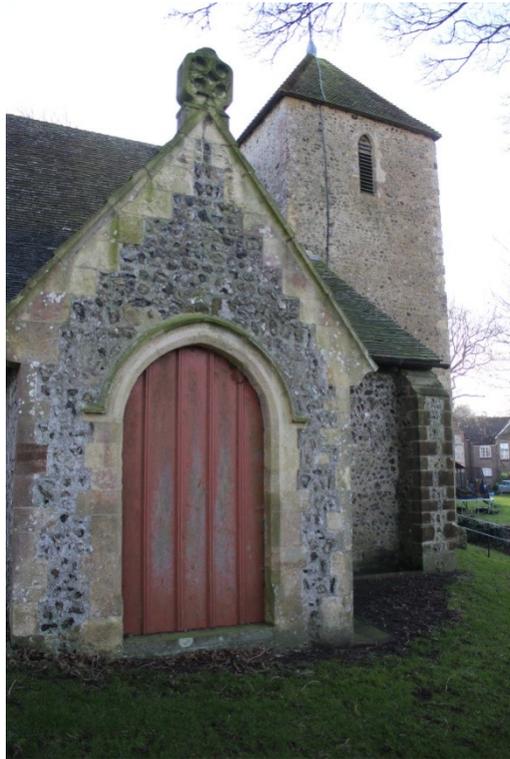
This small 19th century addition matches the porch to the south in both size and construction details except the roof is covered with ceramic tiles instead of Horsham slab. There is also a round-headed stone window in the east wall which matches that in the porch and those in the north wall of the aisle (Plate 23). It is not known if the external door was ever meant to be used as it appears to be in-filled internally (Plate 24).

Plate 24. Blocked north door in the Vestry.

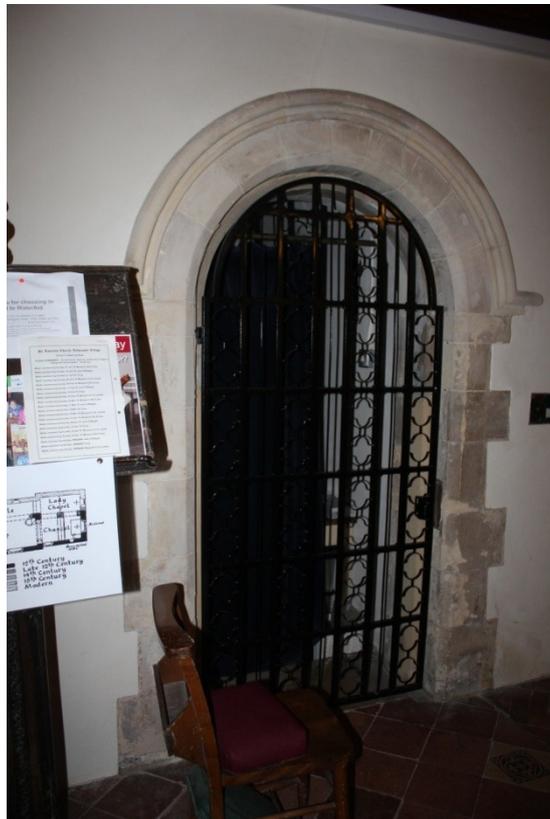
Plate 25. The doorway into the Vestry with modern gate.

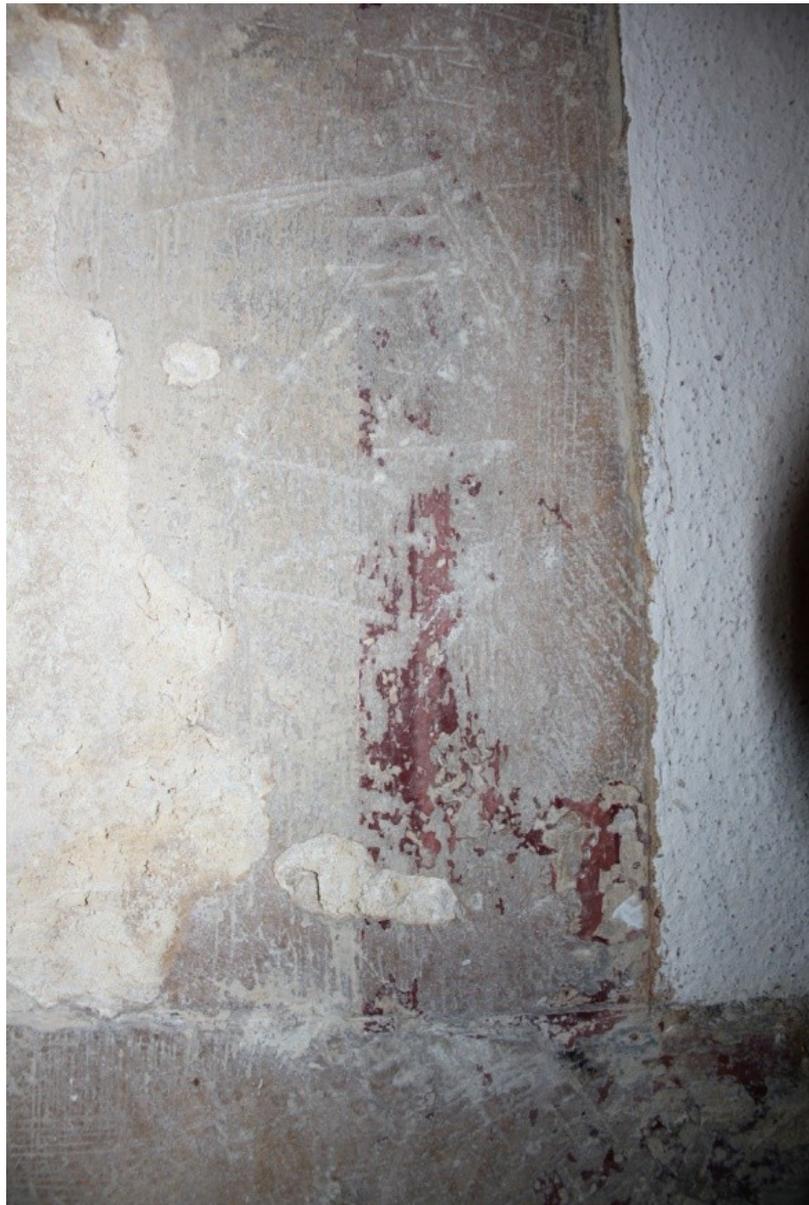
Internally, the doorway into the vestry in the north wall is a two-pointed arch in yellow sandstone (which is probably re-used) with a much later label mould with returns, which does not seem to match any others internally (Plate 25). This doorway is believed to be 19th century which was inserted during the Victorian renovations. However, there is some evidence that this doorway has been re-positioned as this has traces of much earlier wall painting on the bottom quoin, which is in a poor condition, fragmented and faint (Plate 26). No evidence of earlier door pintles was seen on the internal face of the doorway, but this was partly blocked by a metal fixing plate and modern door hinges/lock plate.

Plate 26. Early wall painting evident on the bottom quoin of the Vestry door.

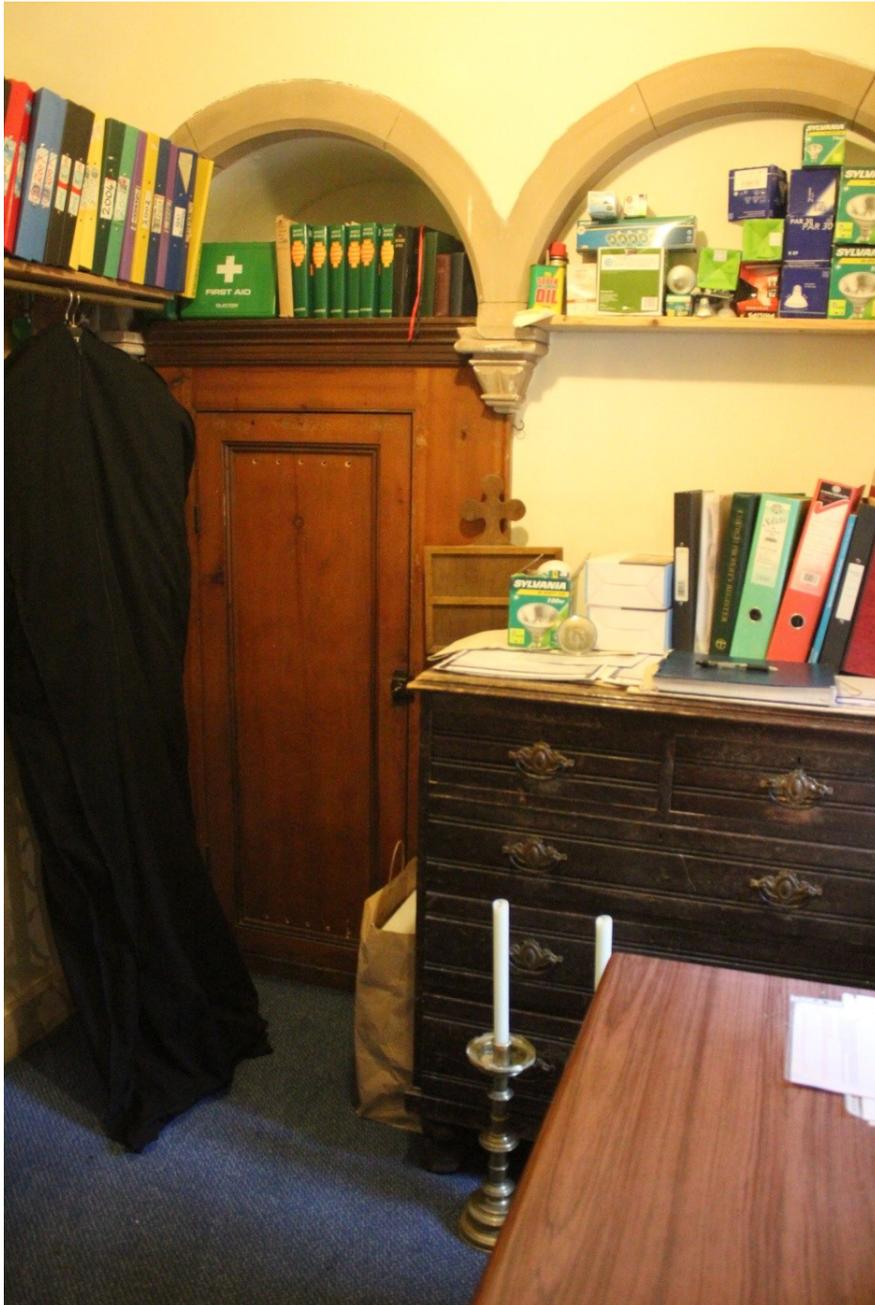
Two arched recess exist in the north wall (Plate 27), behind a blocked external doorway; one on the west side has been partly boarded and used as a bookshelf and cupboard space and the one on the east side appears fully boarded. This is somewhat confusing as the exterior view shows a centrally positioned doorway but internally this does not seem feasible. It is possible that the external doorway was never built for use and is there mainly to achieve some form of symmetry with the south porch. The walls are all plastered and painted white, as is the roof which is flush under-plastered. The floor is carpeted.

Plate 27. Internal recesses behind the external door would not have given easy access.
