**AN ARCHAEOLOGICAL DESK BASED ASSESSMENT FOR THE
PARISH CHURCH OF ST.LAURENCE, TELSCOMBE, EAST SUSSEX.**

Archaeology Services Lewes

Project number: ASL 141-17

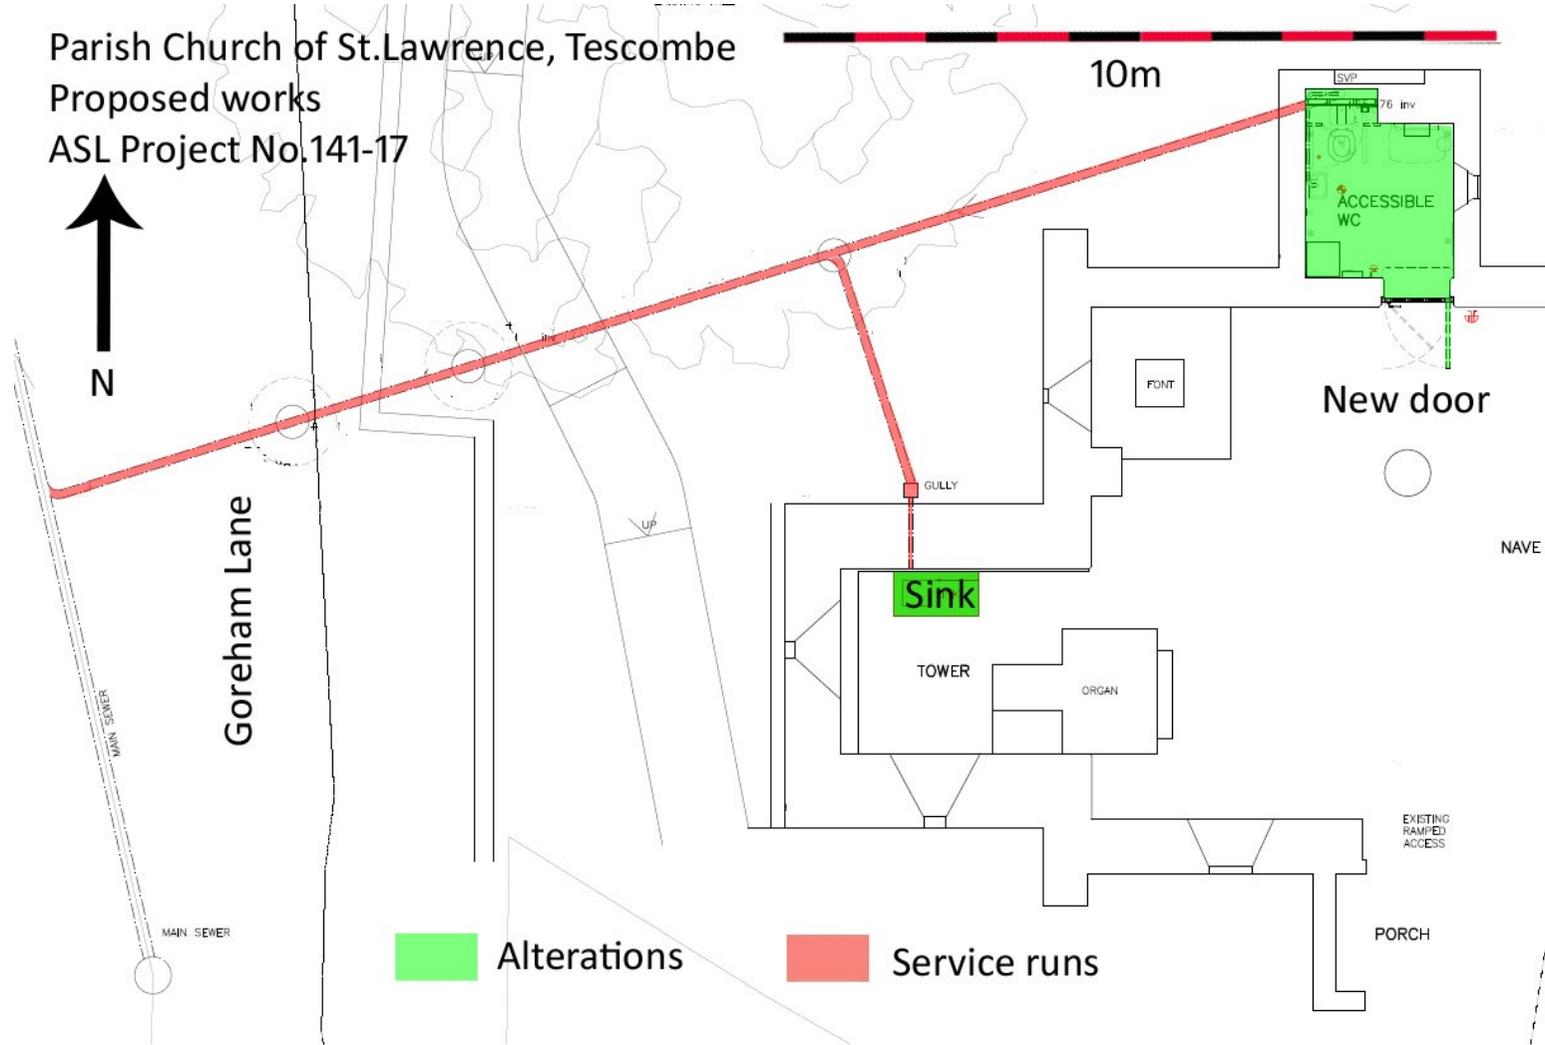
Fig.12 Proposed plans based on J.D.Clarke's plans drawing No.10301/02 (Rev.A).

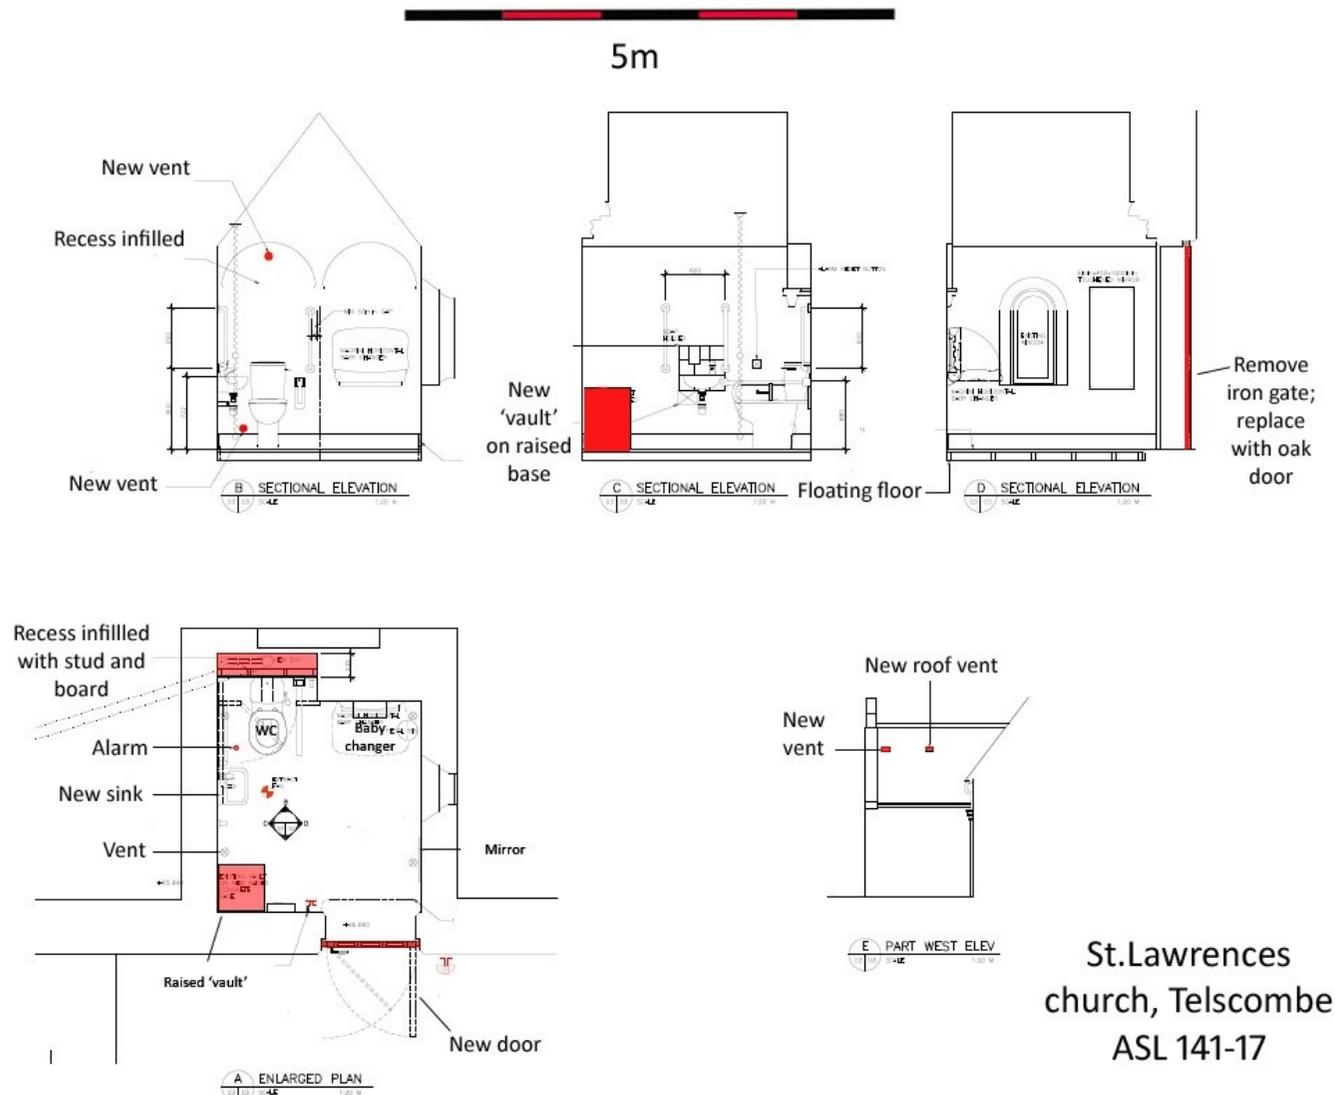
Fig.13 Proposed sections based on J.D.Clarke's plans drawing No.10301/03 (Rev.A).

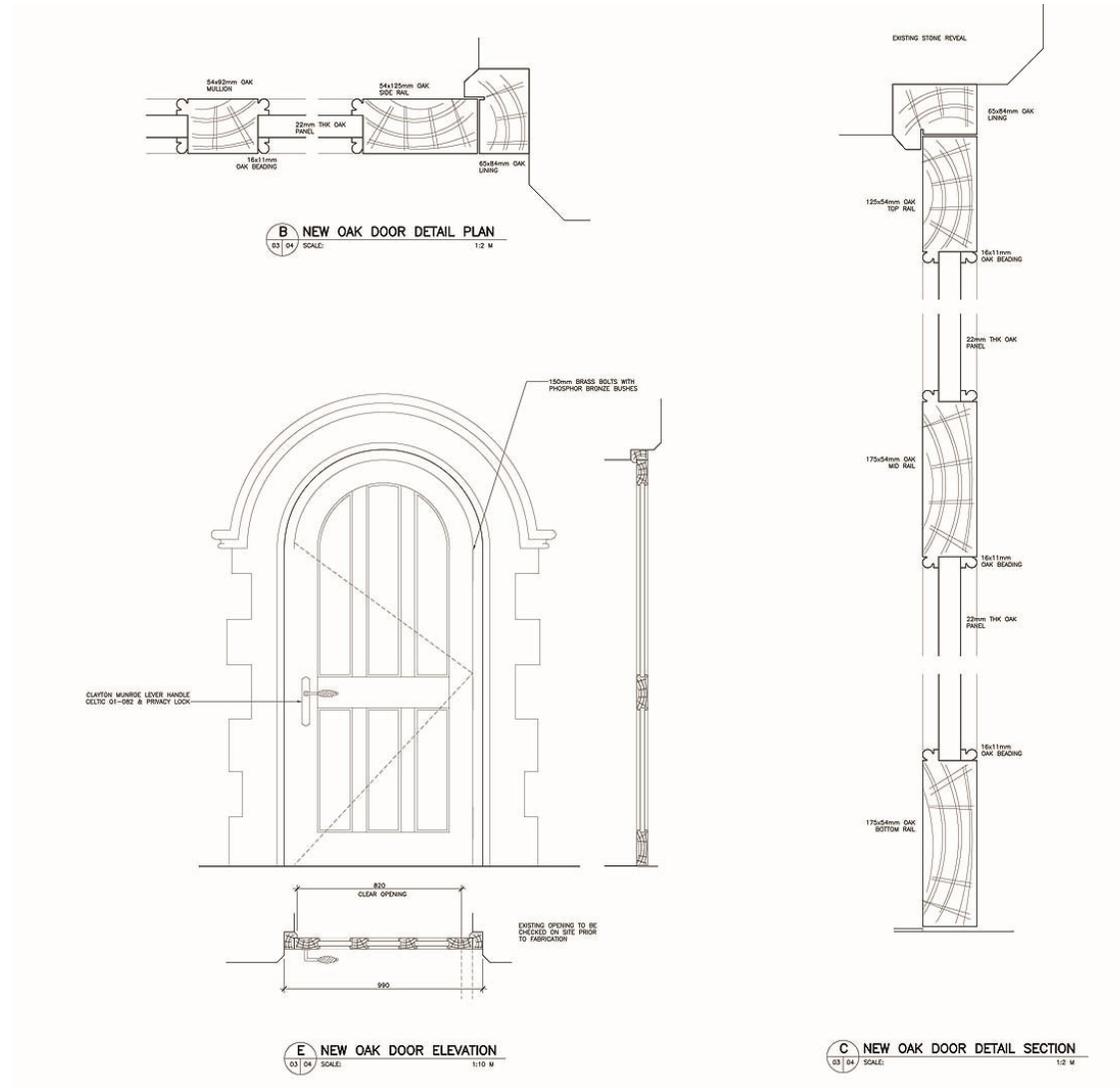
Fig.14 Proposed door design based on J.D.Clarke's plans drawing No.10301/04 (Rev.A).
